AVIATION INVESTIGATION REPORT

A00Q0114

RUNWAY INCURSION

AIRBUS INDUSTRIE A319-114 C-FYJG

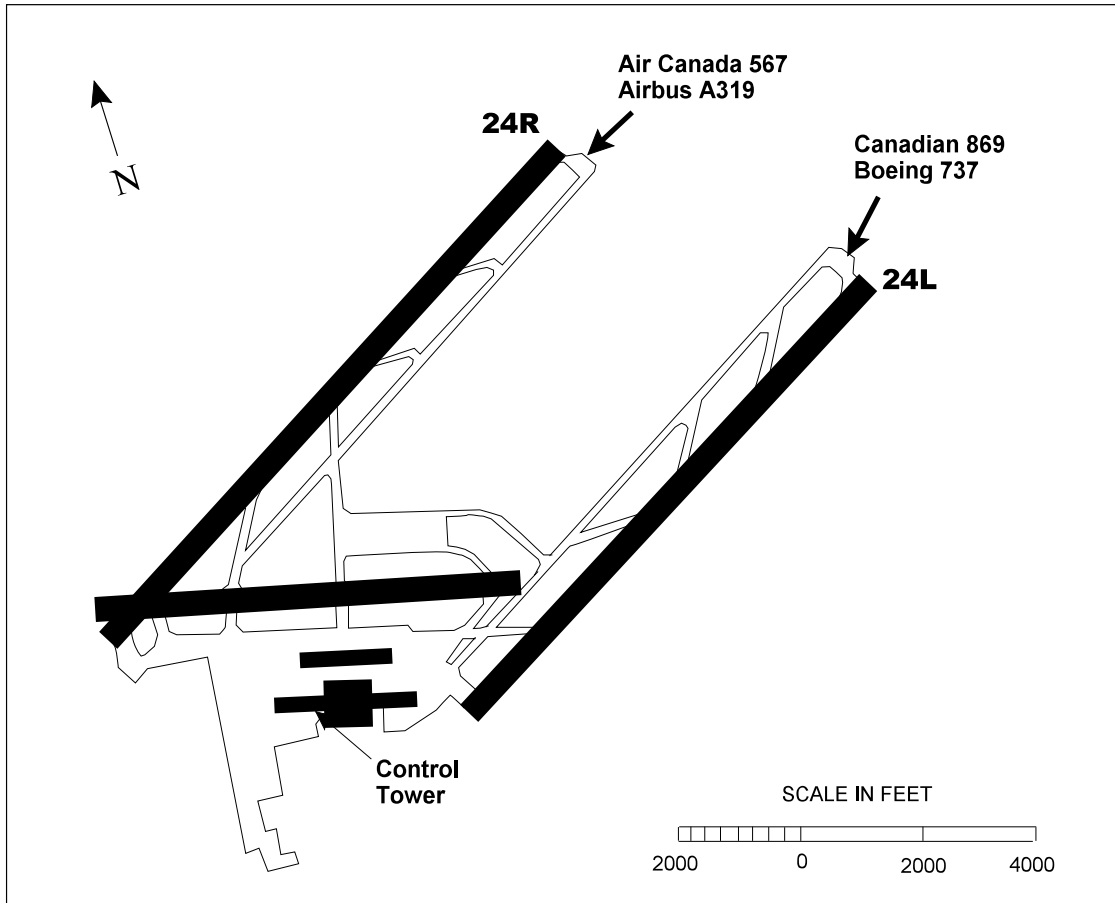
Appendix A—Montréal International Airport (Dorval)

ACA567 contacted the airport controller on handover from the ground controller at approximately 0914 eastern daylight time by advising that ACA567 was “with” him. At the time, the airport controller was dealing with ACA381 on final for runway 24R, several other airborne aircraft in the vicinity, and three other aircraft on the ground. Canadian 386 had just landed on runway 24R. Delta 1933 was given take-off clearance on runway 24L, and Canadian 869, a Boeing 737, was waiting in the holding bay of runway 24L (see Appendix A).
